PYROTEK MZR-755 A SUCCESS FOR SWISS GALVANIZER

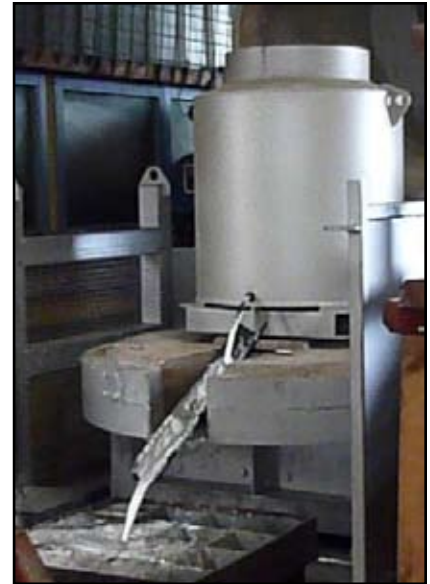
MZR equipment system in operation

The MZR unit is essentially a thermo-mechanical device, which effectively extracts valuable, reusable zinc from operators’ bath skimmings and top drosses.
